Voluntary Compliance with Forestry Best Management Practices in East Texas

Results from BMP Compliance Monitoring Project

TEXAS FOREST SERVICE
Forest Resource Development Department

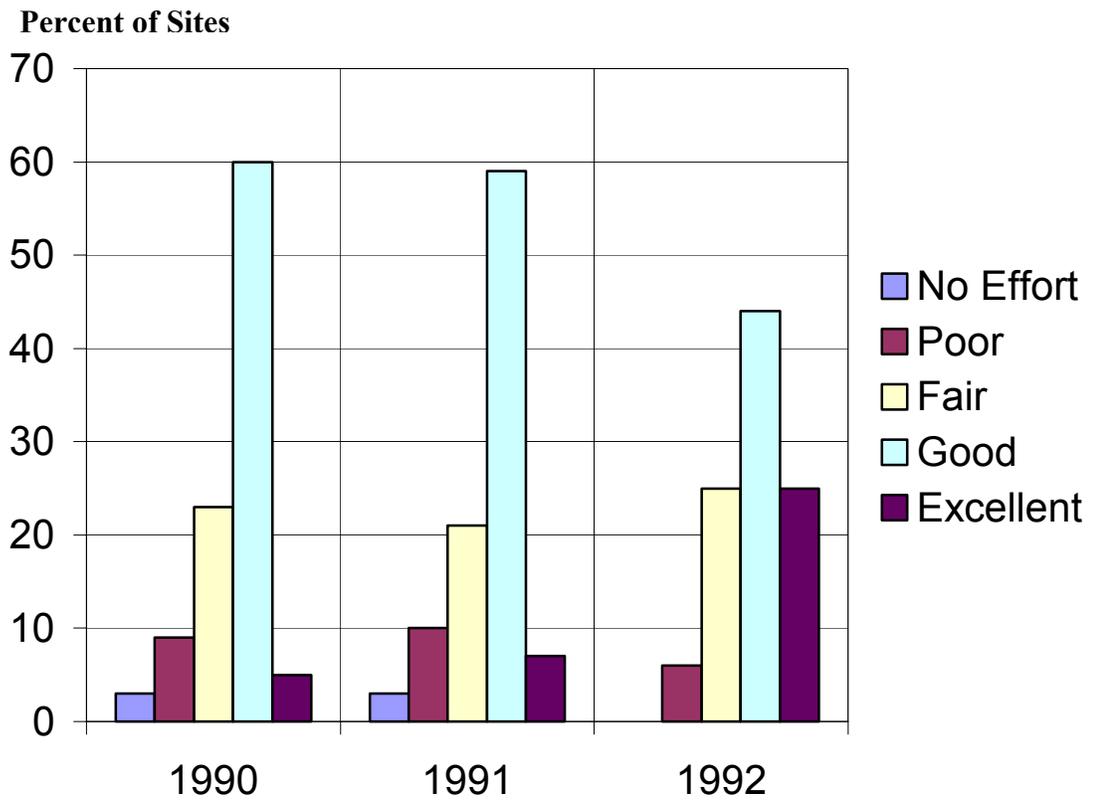
Figure 10
Overall Compliance by Year of Activity

As shown in Figure 10, BMP compliance has improved somewhat over time, and showed marked improvement in 1992. The average score for sites on which the activity was completed in 1990 was 3.57 out of 5.0, with 89 percent of sites receiving a passing rating of Fair or better.

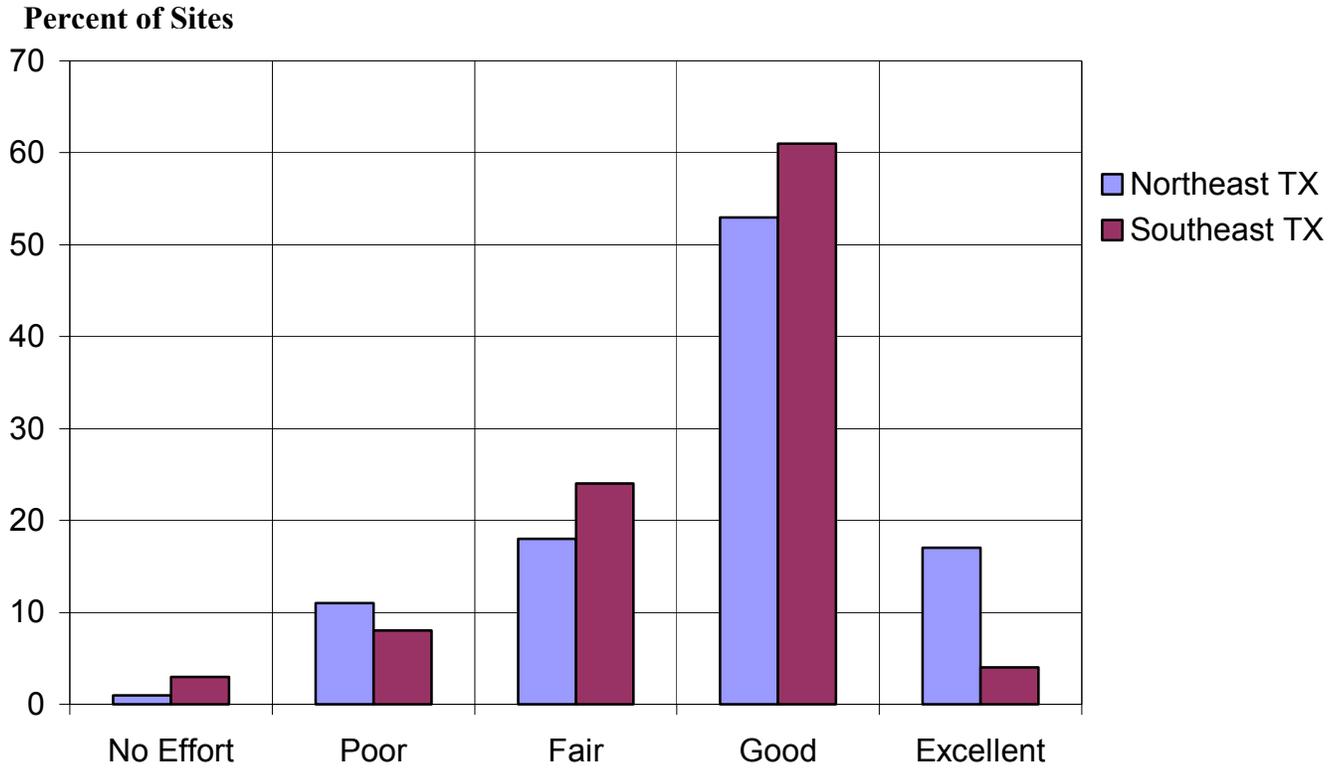
Figure 11
Overall Compliance by Region

Figure 11 shows compliance rating distribution by region. The average score for 101 Southeast Texas sites was 3.55, while the average for the 61 Northeast sites was 3.70. This would seem to indicate better compliance in Northeast Texas, however, this is not the case. Eighty-seven percent of Northeast Texas sites received a passing grade of fair or better, while 89 percent did so in Southeast Texas. Northeast Texas had a larger share of Excellent ratings, but this was offset by a high proportion of Poor grades. Figure 11 illustrates the distribution of ratings by region.

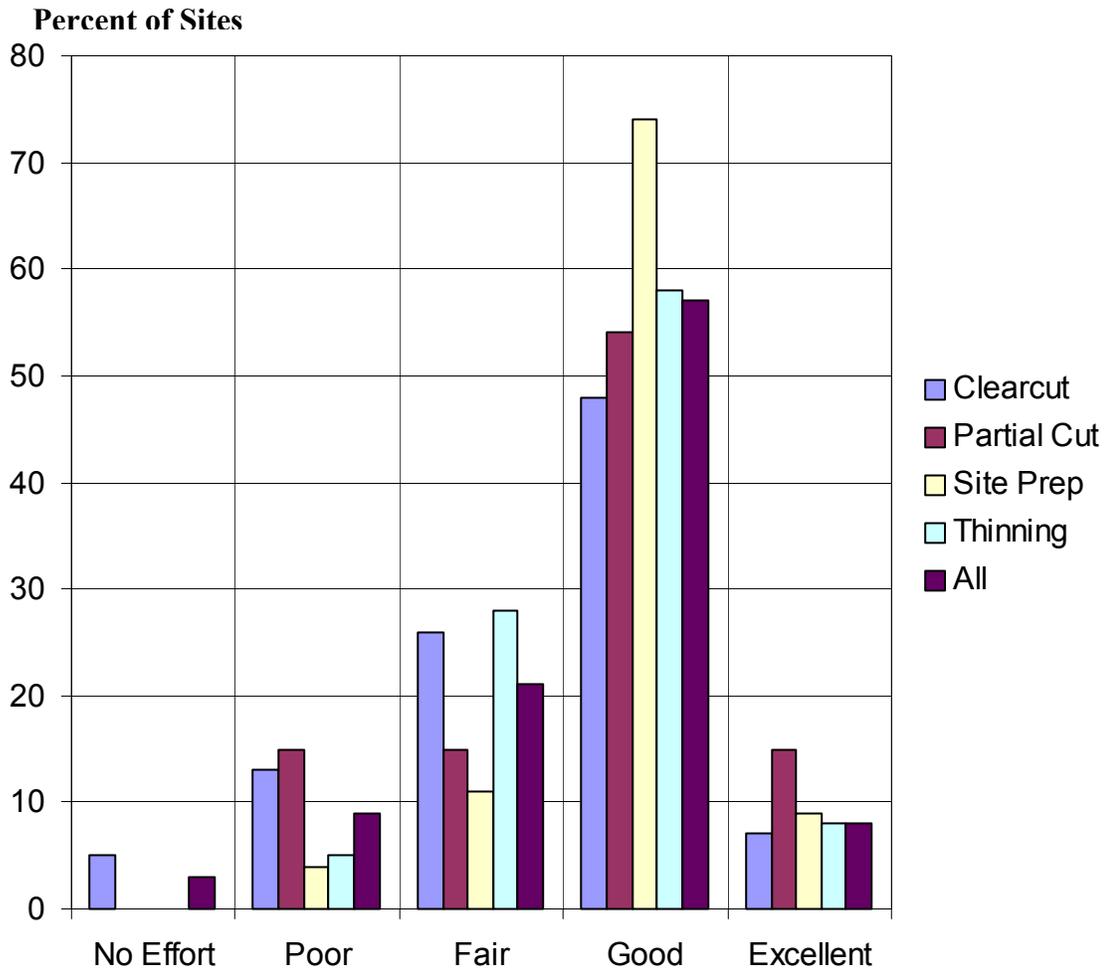
Figure 13
Overall Compliance by Type of Operation

Four types of operations were monitored: clearcuts, partial regeneration cuts, site preparation, and thinning. Results by type of operation are illustrated in Figure 13. Site preparation activities on 43 sites received a Fair or better rating 95 percent of the time, and had the highest average score at 3.9. Thinning operations (36 sites) passed on 94 percent of the sites, yielding an average score of 3.7. Thirteen partial regeneration harvests, such as seedtree and shelterwood cuts, were evaluated. These rated Fair or better in 85 percent of the cases and had a 3.7 average. Clearcut received the worst overall scores. Seventy clearcuts were evaluated, with results indicating a Fair or better rating 81 percent of the time, and an average score of 3.4.

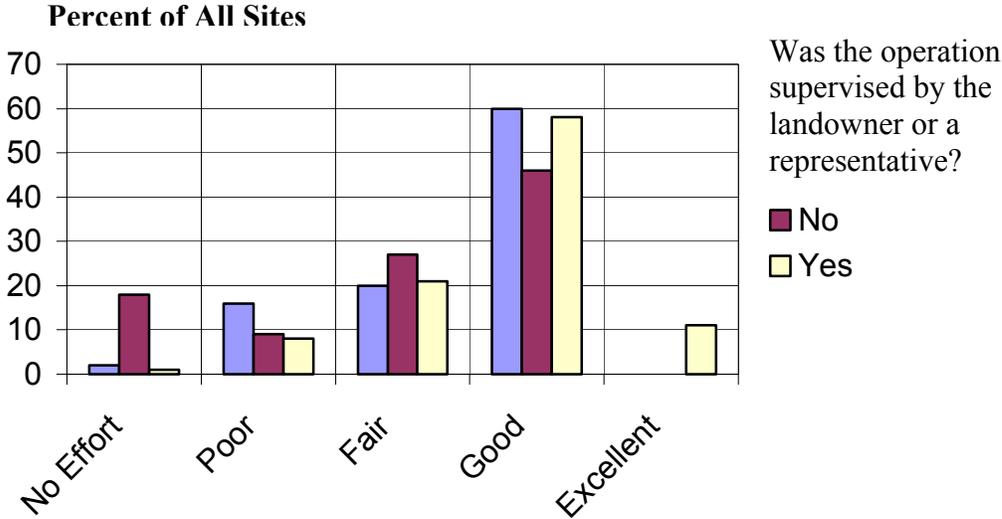
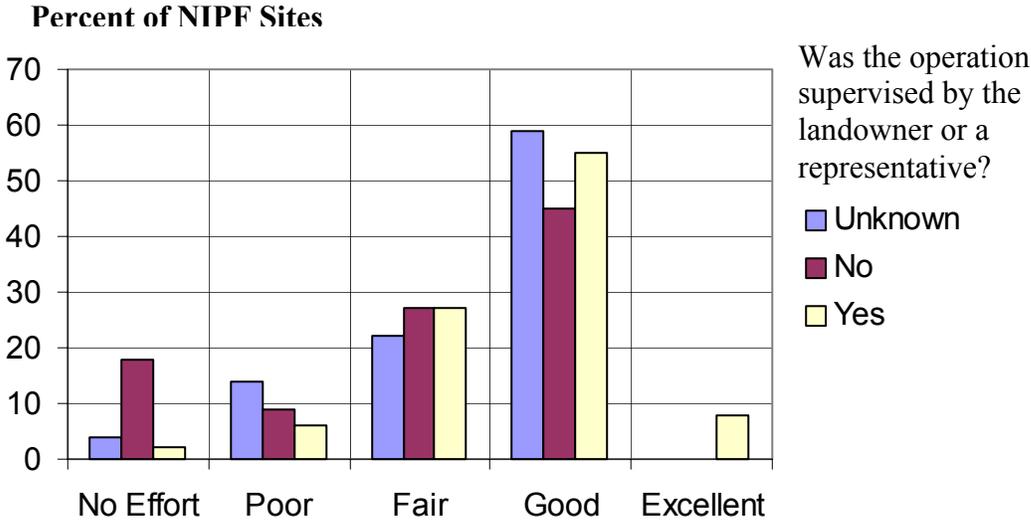
Figure 16
Overall Compliance by Level of Supervision

Sites on which the activity was supervised by either the landowner or a landowner representative (e.g., a consulting forester) generally had a greater level of compliance and less impact on water quality than those that had no supervision (Figure 16). Of the 162 sites, supervision was reported for 126. Eleven sites reported that there had been no supervision of the activity, and level of supervision could not be determined for 25 sites.

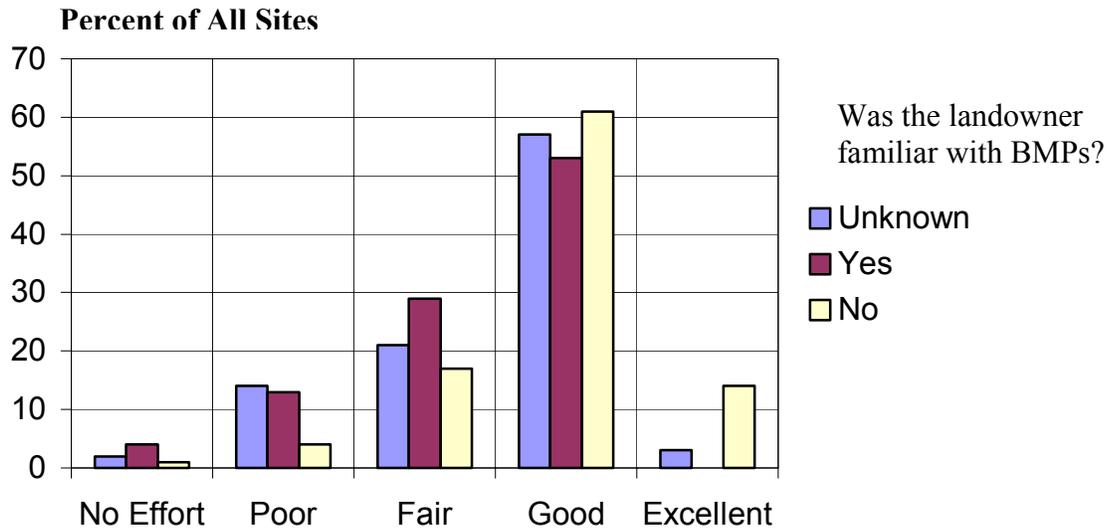
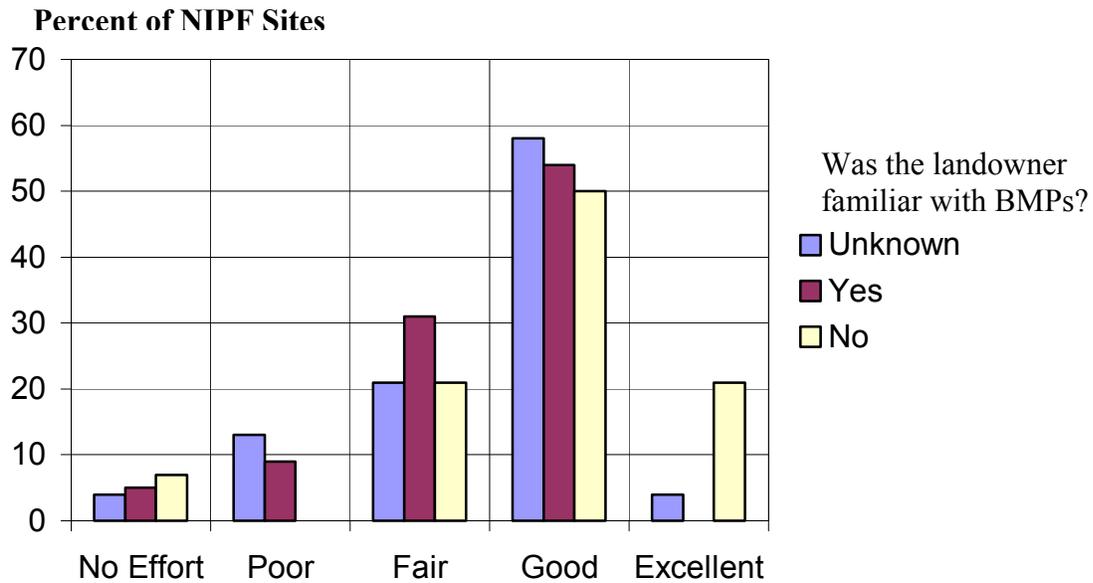
Figure 17
Overall Compliance by Landowner Knowledge

Landowner familiarity with BMPs seems to be an important factor in the level of compliance (Figure 17). Landowners expressing familiarity with BMPs had a passing rate of 93 percent and an average score of 3.8. Those without such familiarity passed at a rate of 86 percent and had a 3.4 average score. Landowners indicated previous knowledge of BMPs on all sites receiving Excellent ratings. Landowners with BMP knowledge also had a higher proportion of Good ratings and lower proportions of Fair, Poor, and No Effort ratings. This pattern held true in general for all owners as a group and for NIPF owners as well.

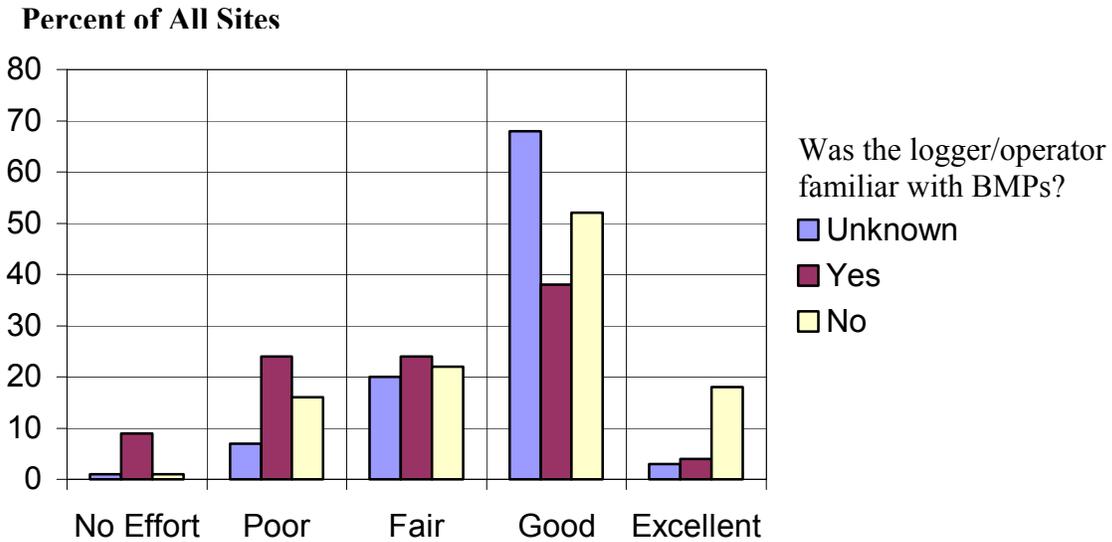
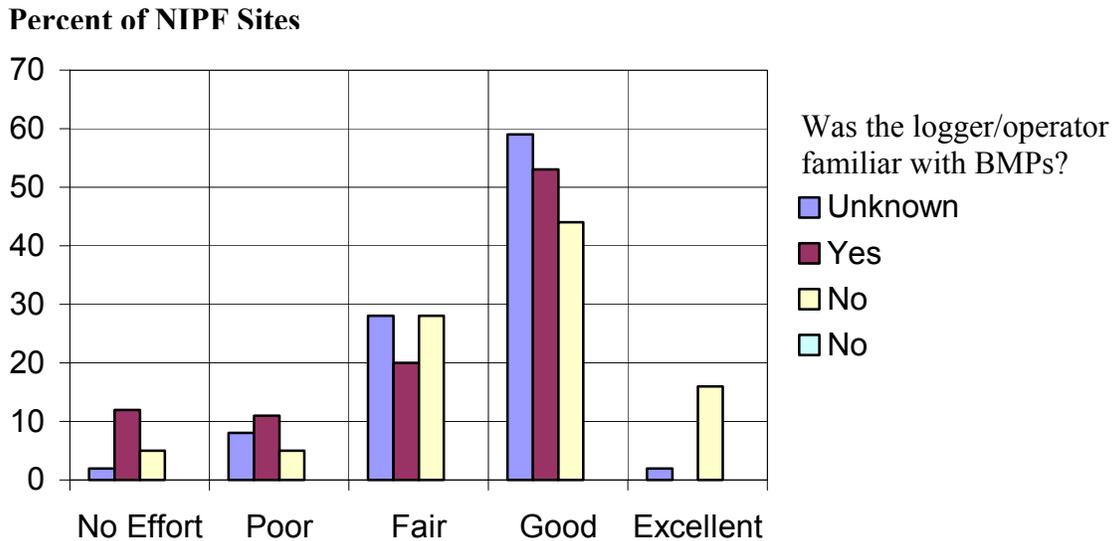
Figure 18
Overall Compliance by Logger/Operator Knowledge

The loggers and other silvicultural contractor's familiarity with BMPs also seems to influence overall compliance, as shown in Figure 18. The difference in passing ratings is striking. Where operators were familiar with BMPs, 92 percent of the sites received a passing rating. Only 66 percent of sites passed when the operator did not have prior familiarity with BMPs. Sites where the operator was familiar with BMPs had higher proportions with ratings of Excellent and Good, and an average score of 3.8. The average score was 3.1 for sites where the operator was not familiar with BMPs.

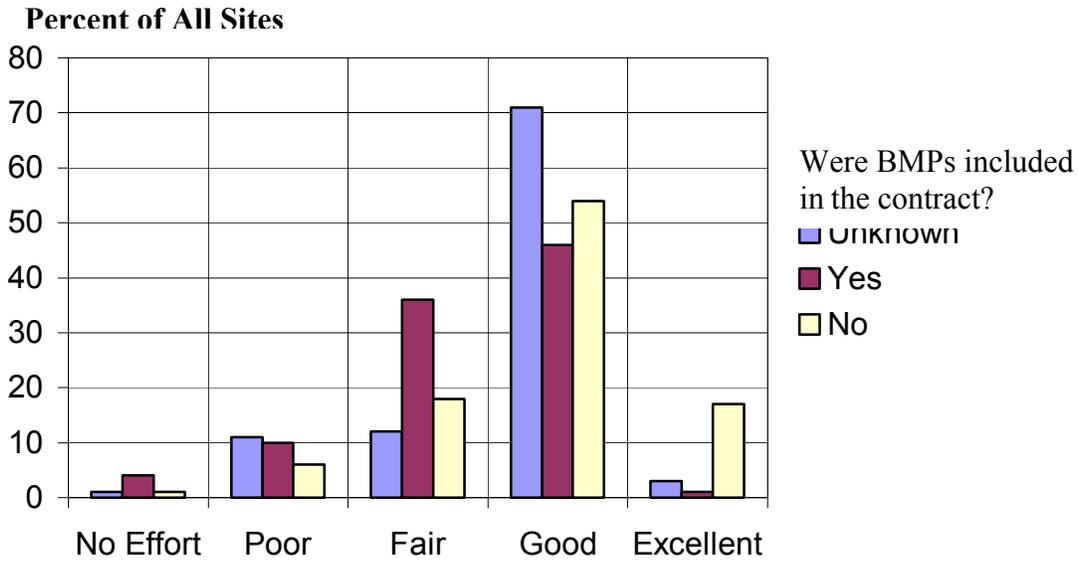
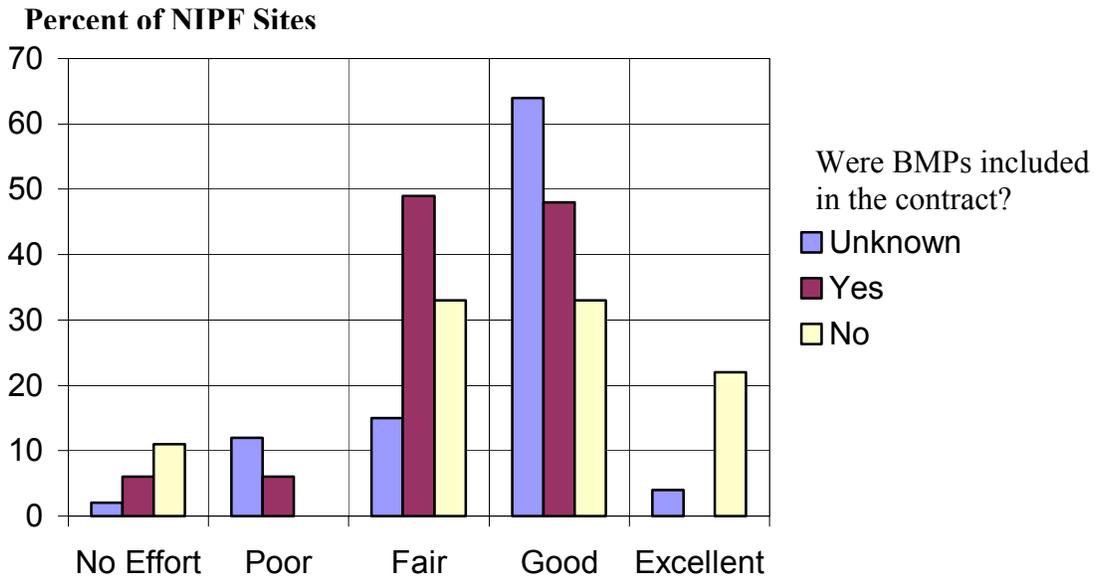
Figure 19
Overall Compliance by Inclusion of BMPs in Contract

When BMPs are specified in the contract between the landowner and operator, compliance is generally better (Figure 19). Ninety-two percent of sites where BMPs were included in the contract received a Fair or better rating, compared to 85 percent of the tracts without BMPs specified in the contract. The average score was 3.8 when BMPs were in the contract compared to 3.3 otherwise. This finding is true for NIPF tracts as well, although in most cases BMPs are not included in a contract (many NIPF timber sales involve no written contract at all). For NIPF tracts, all sites receiving an Excellent rating had contractual BMPs.

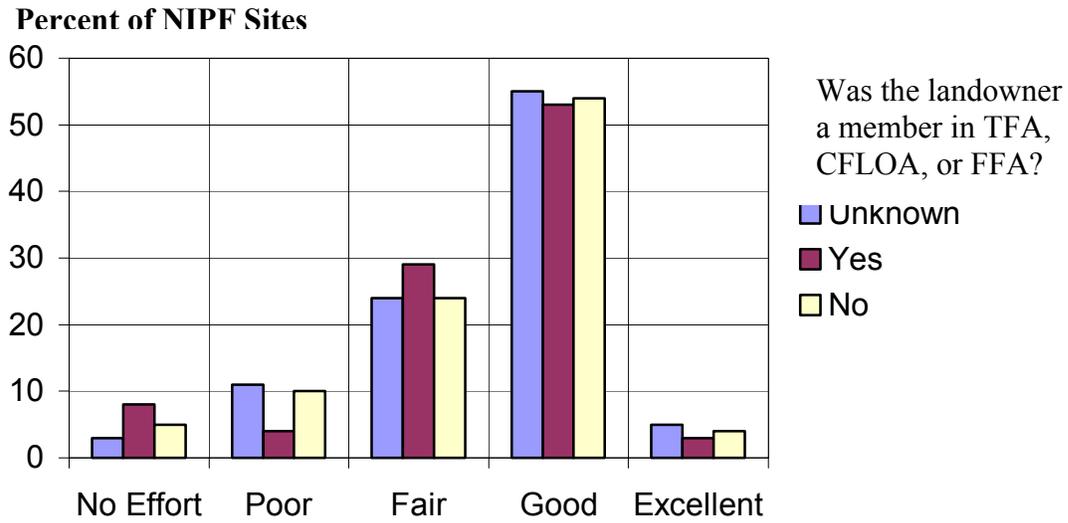
Figure 20
Overall Compliance by Forestry Organization Membership

Figure 20 shows the distribution of compliance ratings by whether or not the NIPF landowner was a member of a forestry organization (Texas Forestry Association, a county forest landowner association, or Forest Farmer's Association). Results do not indicate any strong correlation between association membership and BMP compliance. However, the sample size for responses to this questions was relatively small, since a yes/no answer was only obtained for 44 sites.
